Conservation Plan and Restoration Work of the Ranzan Country Club Clubhouse

Ranzan Country Club is a golf clubhouse built in 1961, designed by architect Taro Amano, a student of F.L. Wright. It was selected in 2014 for the *docomomo Japan 174*, a selection of 174 important modern buildings compiled by *docomomo* Japan. After completion, it underwent unplanned extension and reconstruction work a number of times. A new conservation and restoration plan began in 2010, and the project is now in the 5th stage. Following a master plan, construction work has been carried out whilst the clubhouse has continued in operation. The building is owned by a private company and has not been designated as a cultural property. The process of this conservation and restoration project serves as a leading example for similar projects in the future.

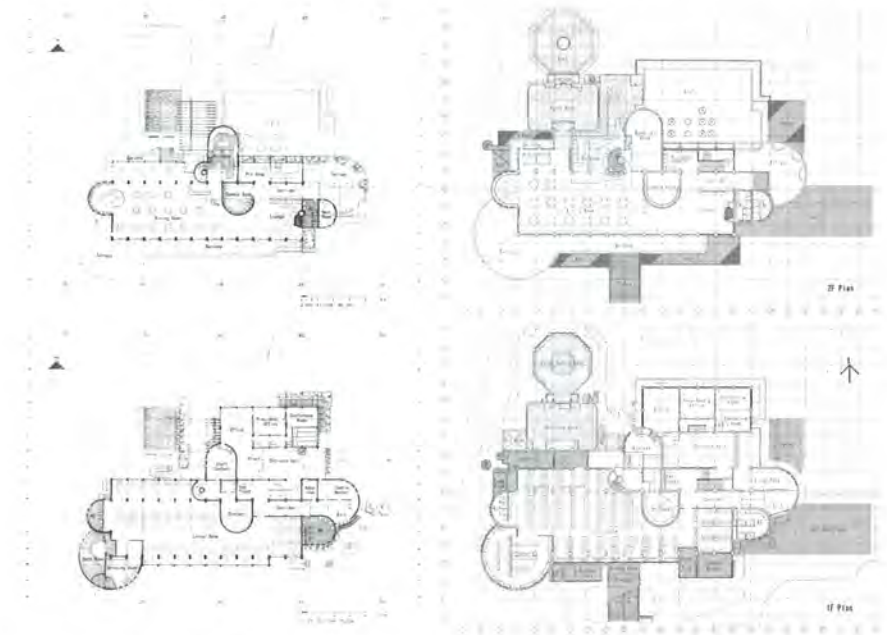
As the result of the actual measurement survey and documentary search, it was discovered that the building had undergone major extension and reconstruction work four times by 2010, and that it had lost a number of its principle elements. The floor area had been increased to 700m². The interior and exterior design of the building had been marred by the following changes: 1) loss of parts

FIGURE 2. Ranzan Country Plan. The left side is completed at that time. The right side at the time in 2010. © Amano Yoshiwara and Partners, Architects, now owned by Meguro architecture laboratory.

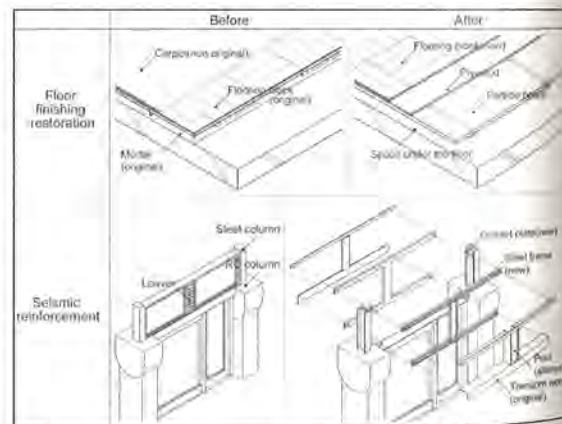
FIGURE 3. Renovation of floor detail and seismic strengthening detail.
© The paper's authors.

Type (B) works included reproduction of flooring. Many flooring blocks were significantly deteriorated, their mortar foundation was problematic because of its weight and impact on seismic performance. Further, removal of the mortar allowed installation of a false floor and, by arranging wires under the floor, flexible furniture layout became possible. Without changing floor level.

In Phase B in 2013, the original appearance was reinstated by reproducing the finish of the floor, walls and ceiling of the conversation lounge. The floor finish of the entire building at the time of its completion was parquet timber, but this had been severely damaged shortly after the completion, by metal spikes on golf shoes. It had therefore been changed to carpet. However, current golf shoes mainly have soft spikes, making it possible to put a wooden floor back. A sample area was installed to confirm that this was practical, and to act as a reference for future policy. Also, tests were carried out to assess the possibility of peeling off the thick paint film from wooden elements which had not been originally painted, and assess the impact of this work and its costs. The conversation lounge was converted into a memorial room, to exhibit the history of the club. Furthermore, since the lounge had been narrow and the utilization was low, a trophy case and benches which formed a non-original partition between the lounge and the corridor were removed, and it was decided not to reproduce the original wooden lattice and benches. This allows the lounge to function in an integrated manner with the corridor. In Phase C in 2014, because of the success of the reproduction of the floor finish and paint removal in Phase B, these aspects of were carried out throughout the second floor. Also, chandeliers which were installed throughout the second floor after the building was first constructed were removed, and by utilizing small holes left after the removal, small downlights were added as supplemental lighting, to the original lighting fixtures which were reproduced. In addition, furniture and screens for a small dining room were reproduced. Seismic reinforcing work to recover the eccentric core rate of the second floor was conducted: steel frames which could be inserted within the framework of the existing wooden fittings were made.
